# Inspection Report

John Hurst

**Property Address:**  
3840 Clarks Bridge Rd  
Gainesville Ga 30506

Scott Mitchell  
P.O. Box 771  
Braselton Ga 30517

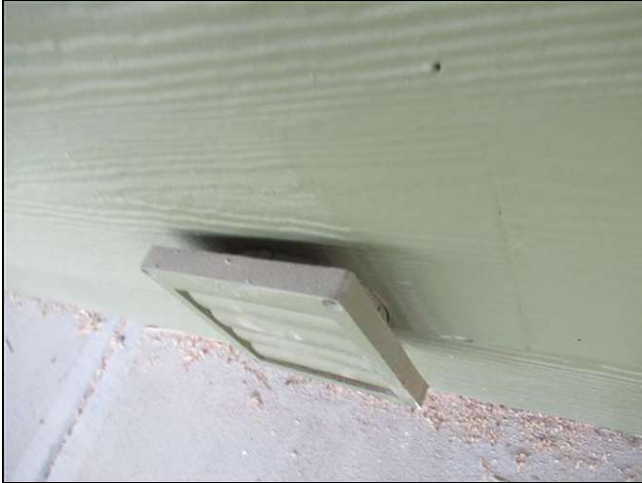
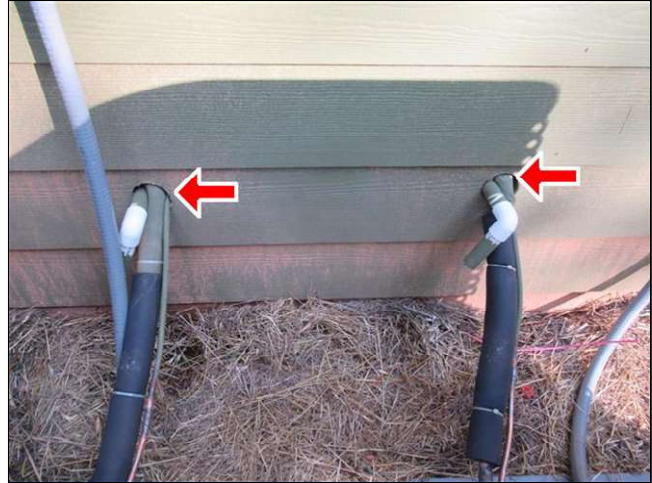
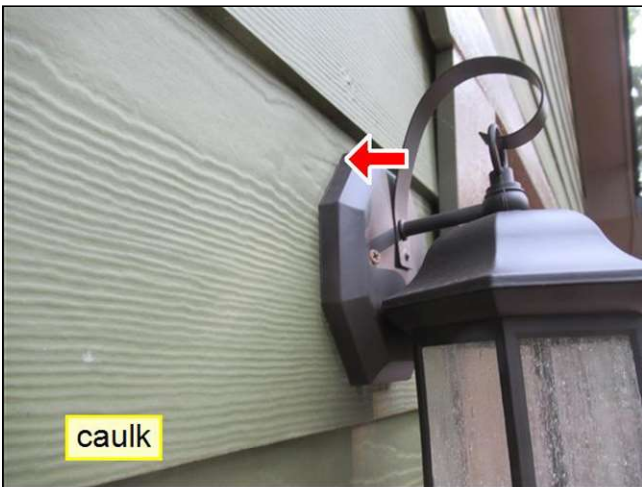
**1.0** The exhaust vent at the right side exterior wall should be secured flush with the wall surface and caulked to help prevent moisture penetration.

The right rear exterior wall should be properly sealed where the air conditioning lines penetrate the wall and rain hoods should be installed above these openings to help prevent moisture problems.

The exterior wall surfaces should be caulked where the light fixtures meet the siding and trim.

Minor repair is needed at the siding above the front entrance lights where holes were drilled.

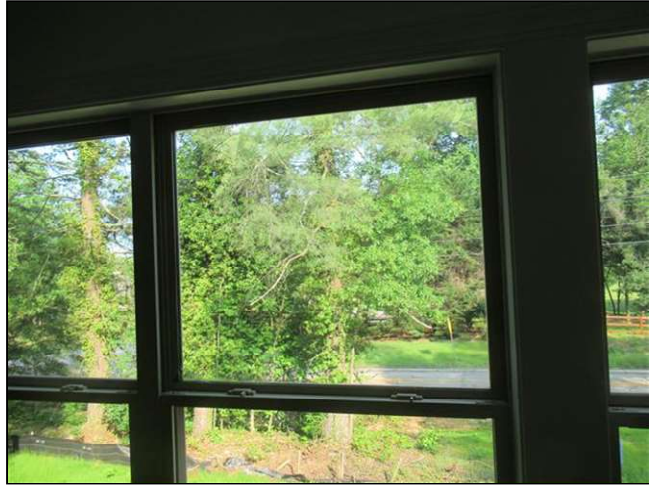
1.1 Item 1(Picture)

**1.1** One window sash has broken glass at the upper floor front bedroom.

One window sash has broken glass at the upper floor front bedroom.

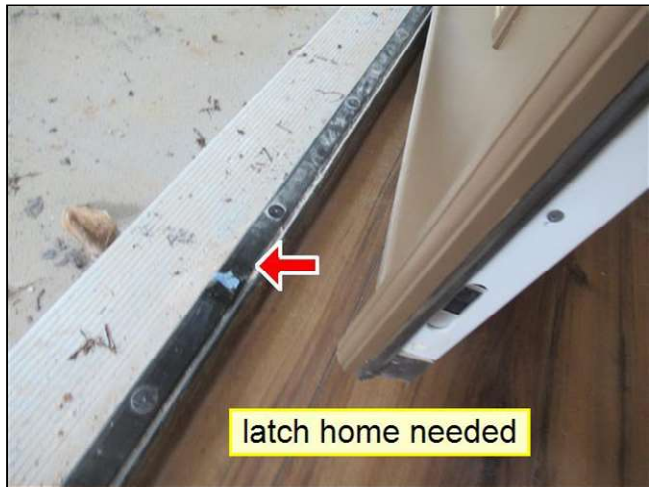
1.2 Item 1(Picture)

**1.2** The right side rear exterior door lower latch should be serviced to catch at the threshold properly.

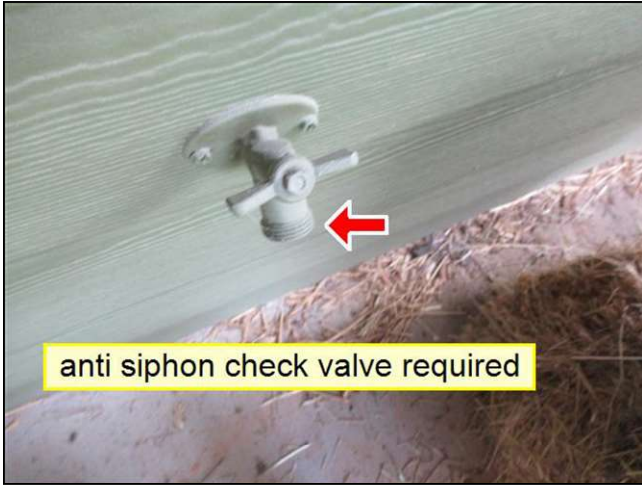
1.5 Item 1(Picture)

**1.5** The exterior water bibs are required to have anti siphon check valves installed for safety.

**P2902.4.3 Hose connection.** Sillcocks, hose bibbs, wall hydrants and other openings with a hose connection shall be protected by an atmospheric-type or pressure-type vacuum breaker or a permanently attached hose connection vacuum breaker.

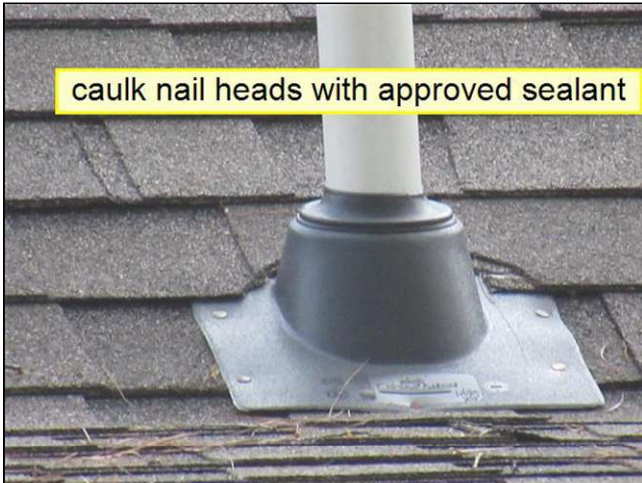
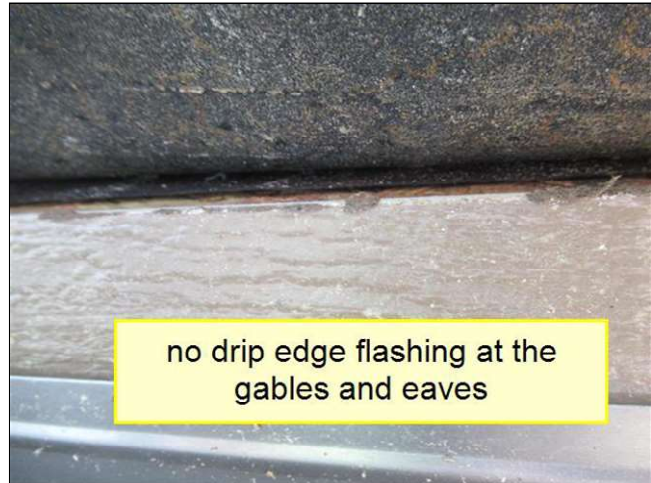
**2.0** Drip edge flashing has not been installed at the roof edges and is required to be installed by code.

The exposed nail heads at the plumbing vent boots on the roof should be sealed to help prevent moisture penetration.

**R905.2.8.5 Drip edge.** A drip edge shall be provided at eaves and gables of shingle roofs. Adjacent pieces of drip edge shall be overlapped a minimum of 2 inches (51 mm). Drip edges shall extend a minimum of 0.25 inch (6.4 mm) below the roof sheathing and extend up the roof deck a minimum of 2 inches (51 mm). Drip edges shall be mechanically fastened to the roof deck at a maximum of 12 inches (305 mm) o.c. with fasteners as specified in Section R905.2.5. Underlayment shall be installed over the drip edge along eaves and under the drip edge on gables. Unless specified differently by the shingle manufacturer, shingles are permitted to be flush with the drip edge.

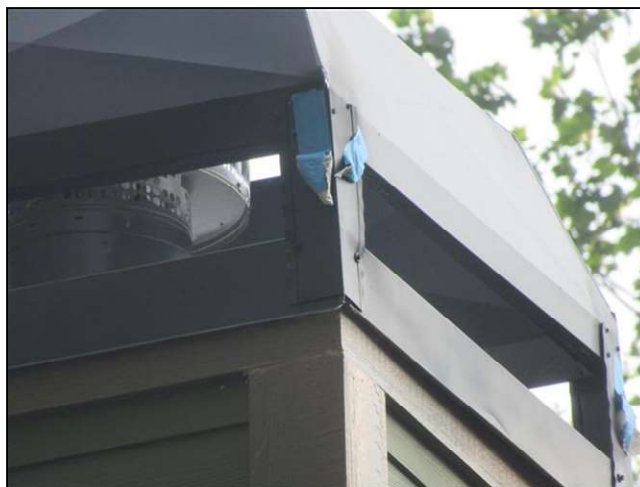
2.4 Item 1(Picture)

**2.4** The chimney is in good condition but there is still tape on the cap.

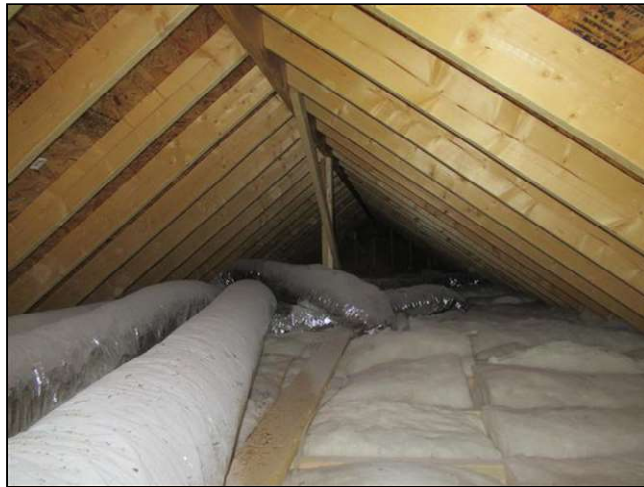
2.6 Item 1(Picture)

**2.6** The visible roof framing is properly constructed and in good condition. The side attic spaces are not readily accessible for inspection. The panels are nailed or screwed down.

The visible roof framing is properly constructed and in good condition. The side attic spaces are not readily accessible for inspection. The panels are nailed or screwed down.

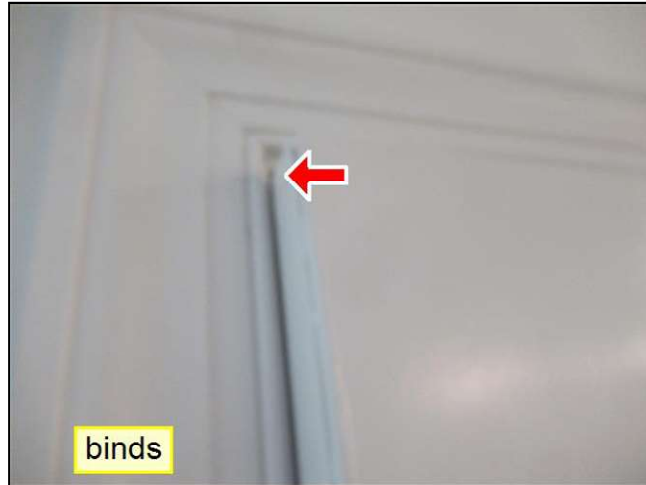
3.4 Item 1(Picture)

**3.4** The interior door at the garage binds slightly at the jamb and should be serviced.

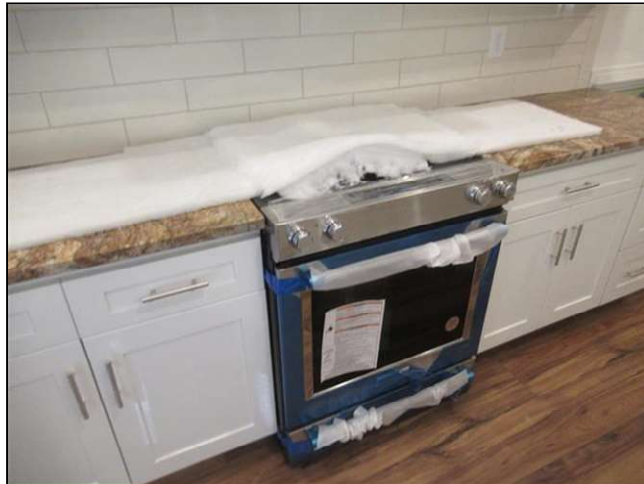
4.10 Item 1(Picture)

**4.10** I did not test the oven. it appears in good condition but has not been started up yet.

I did not test the oven. it appears in good condition but has not been started up yet.

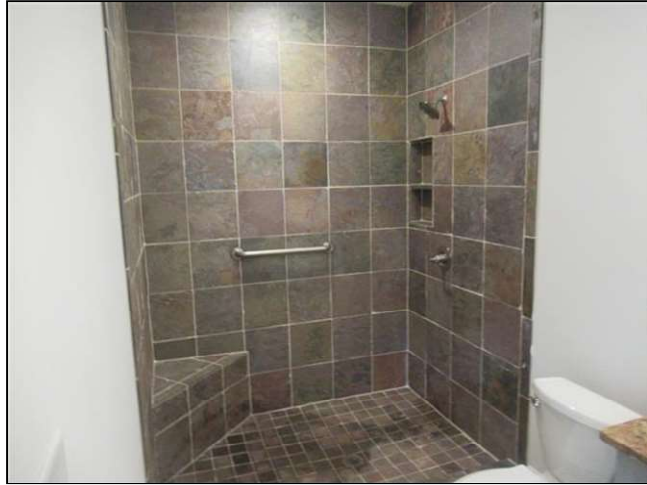
5.1 Item 1(Picture)

**5.1** The master shower glass enclosure has not been installed at this time.

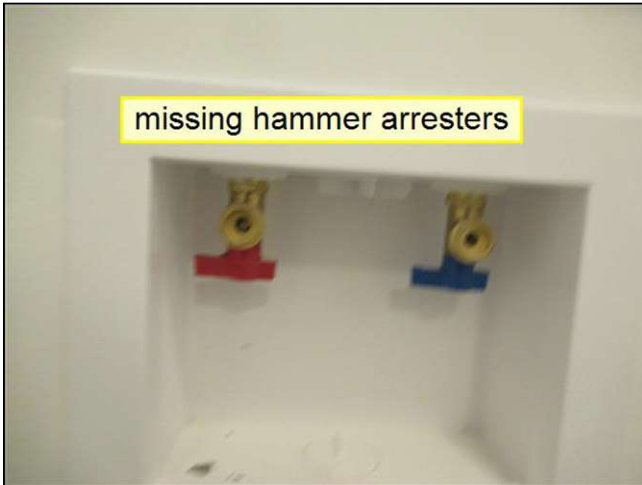
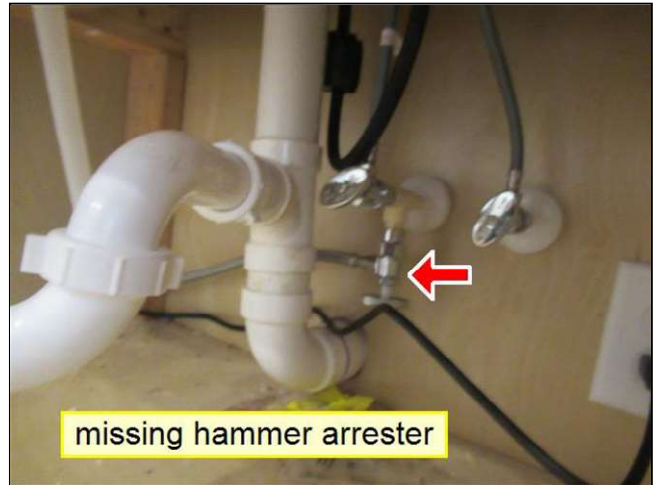
**8.1** The water lines at the refrigerator, Dishwasher and Laundry have quick closing valves and are required by code to have water hammer arresters installed to help prevent plumbing damage (604.9)

The water lines at the refrigerator, Dishwasher and Laundry have quick closing valves and are required by code to have water hammer arresters installed to help prevent plumbing damage (604.9)

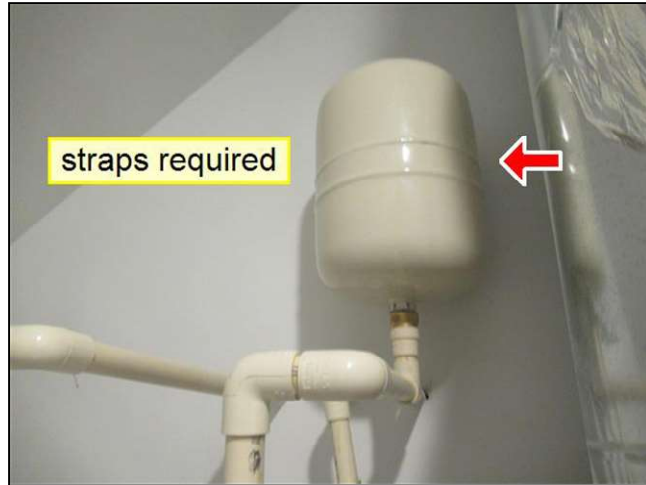
8.3 Item 1(Picture)

**8.3** The fifty gallon water heater is in good condition but the thermal expansion tank is required to be strapped to the wall to prevent damage to the cpvc pipe supporting the tank.

The fifty gallon water heater is in good condition but the thermal expansion tank is required to be strapped to the wall to prevent damage to the cpvc pipe supporting the tank.

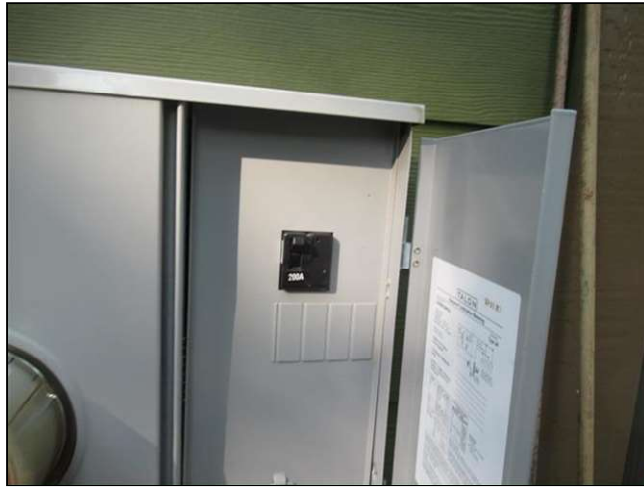
9.1 Item 1(Picture)

**9.1** The main two hundred amp breaker for the system is located at the left side exterior.

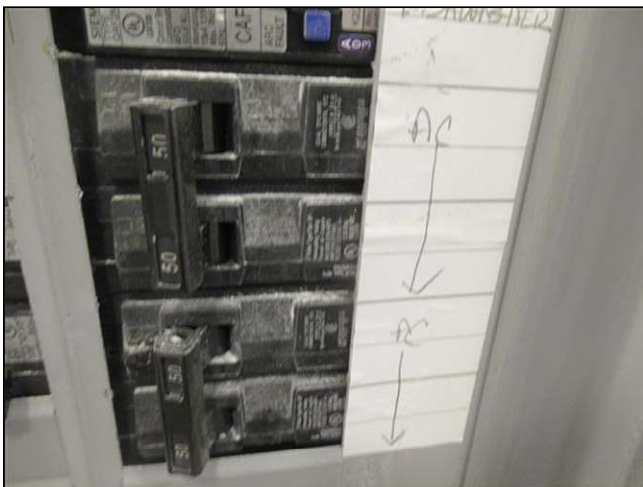
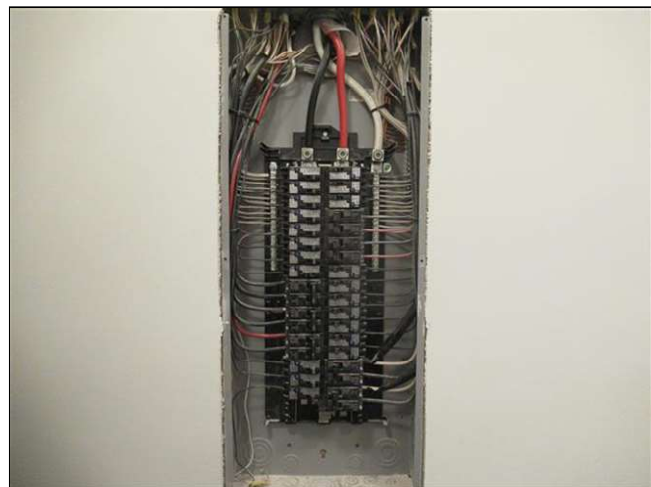
**9.2** The 200 amp power panel wiring is in good condition but the two fifty amp circuit breakers for the two heat pumps are oversized. One of the units requires a maximum thirty amp breaker and the other requires a maximum forty amp breaker.

The 200 amp power panel wiring is in good condition but the two fifty amp circuit breakers for the two heat pumps are oversized. One of the units requires a maximum thirty amp breaker and the other requires a maximum forty amp breaker.

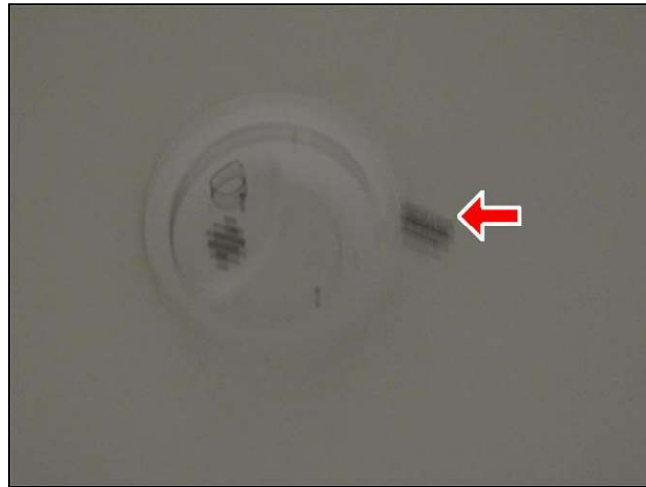
9.3 Item 1(Picture)

**9.3** The smoke detector batteries should be activated by removing the plastic sleeves.

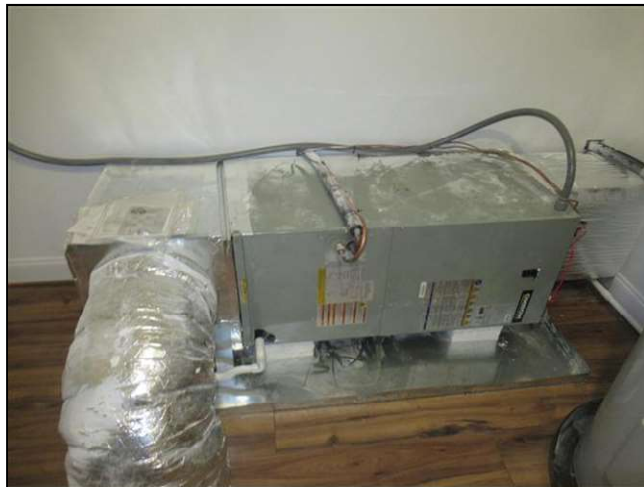
10.2 Item 1(Picture)

**10.2** The air handlers are in good condition.

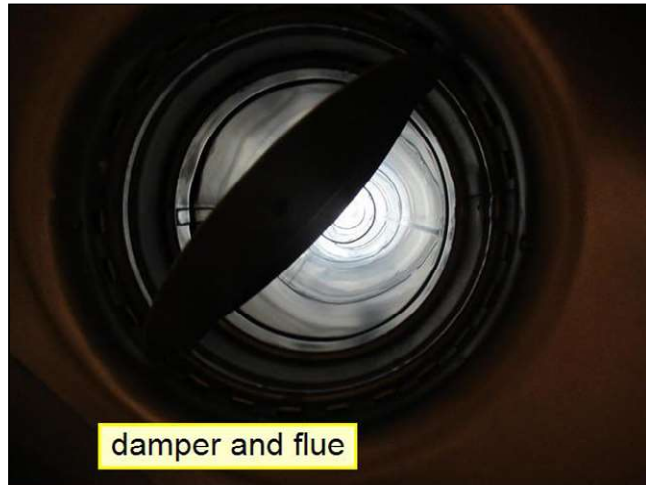
10.5 Item 1(Picture)

**10.5** The fireplace damper and visible flue are in good condition. The gas starter hardware is installed to be able to connect a gas tank in the future. The test gage is still installed at the exterior end of the gas line. This should be removed and the line capped.

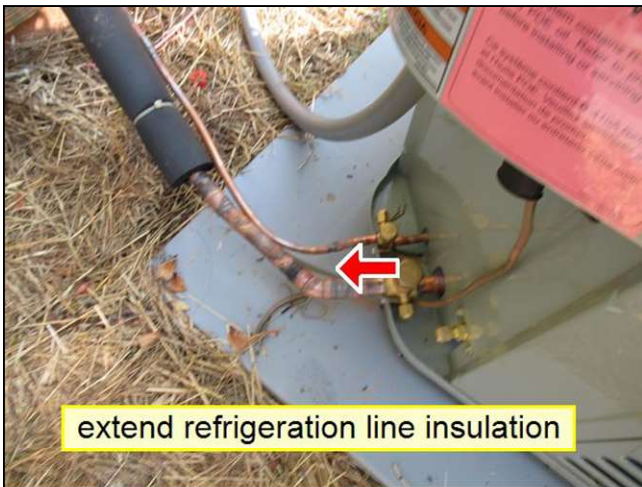
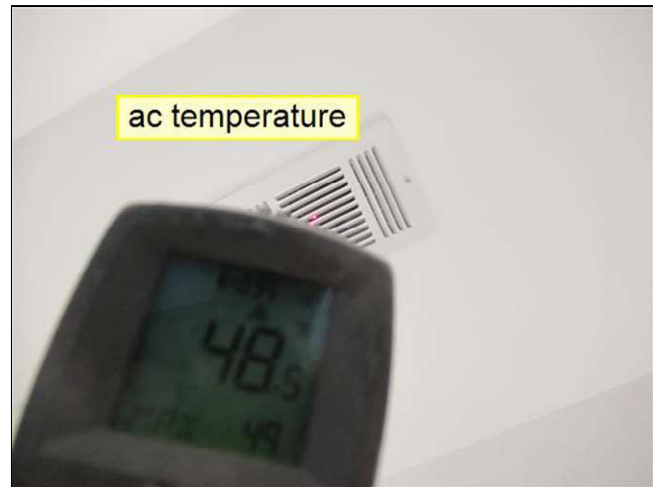
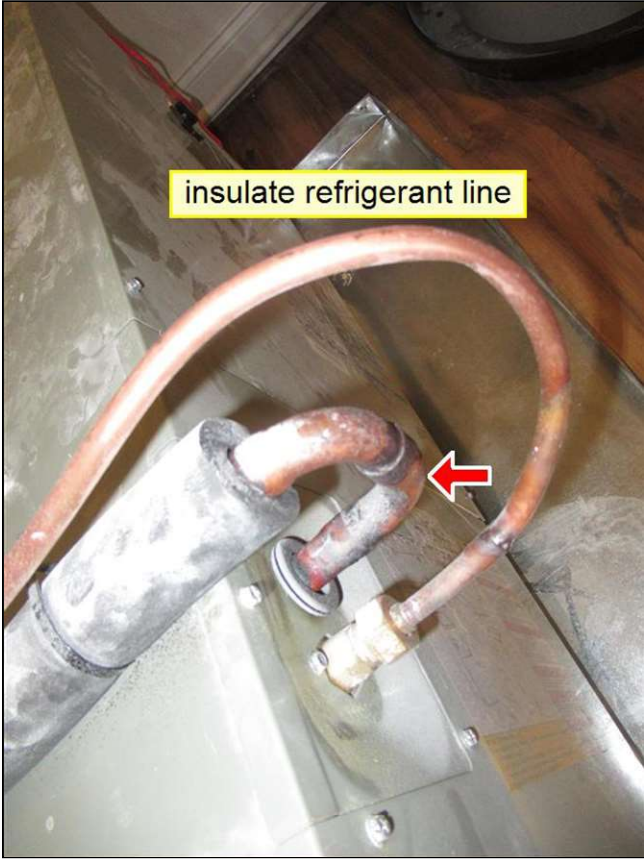
**10.8** The HVAC system refrigerant line insulation is missing at a small area at the air handler area. This causes condensation to collect and drip from the line. The line should be insulated and caulked at the coil wall. The refrigerant line also needs additional insulation at one of the units at the exterior for improved efficiency. Both three ton systems are cooling properly.

The HVAC system refrigerant line insulation is missing at a small area at the air handler area. This causes condensation to collect and drip from the line. The line should be insulated and caulked at the coil wall. The refrigerant line also needs additional insulation at one of the units at the exterior for improved efficiency. Both three ton systems are cooling properly.
