# Inspection Report

John Hurst

**Property Address:**  
3840 Clarks Bridge Rd  
Gainesville Ga 30506

Scott Mitchell  
P.O. Box 771  
Braselton Ga 30517

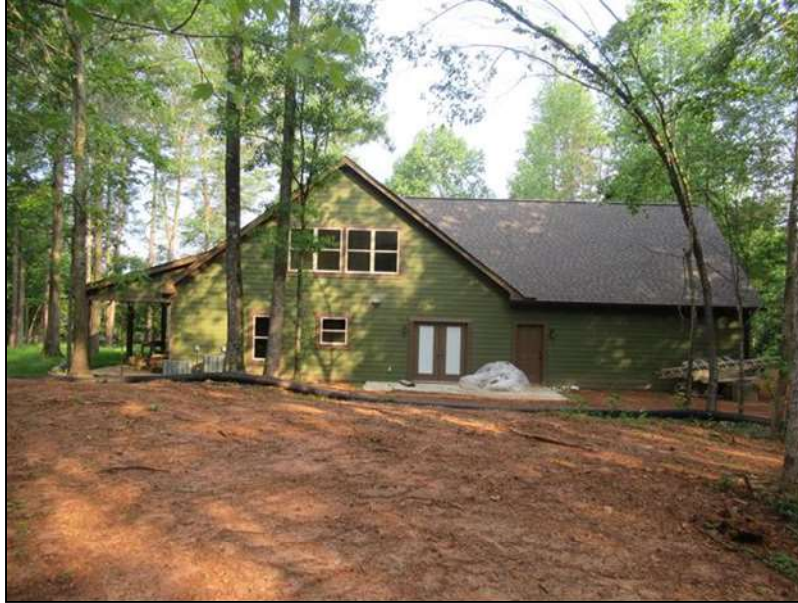
**1.0** The exhaust vent at the right side exterior wall should be secured flush with the wall surface and caulked to help prevent moisture penetration.

The right rear exterior wall should be properly sealed where the air conditioning lines penetrate the wall and rain hoods should be installed above these openings to help prevent moisture problems.

Minor repair is needed at the siding above the front entrance lights where holes were drilled.
